# EXHIBIT “A-1”

February 26, 2016

Insured:	Joseph & Ursy Vitale
Loss Location:	1812 Purdie Lane Maple Glen, PA 19002
Co. Claim #:	0339957135
Date of Loss:	9/4/14
Type of Loss:	Fire
WGI File #:	60294

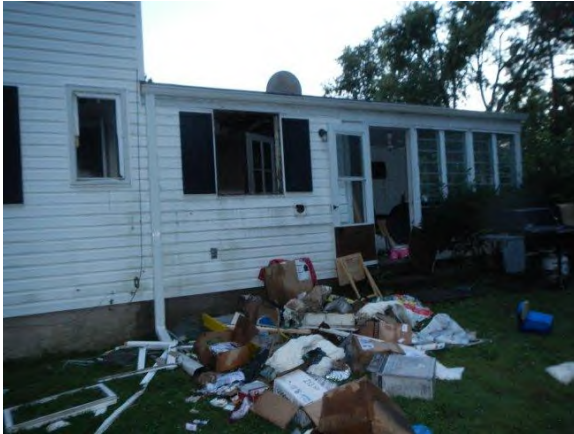
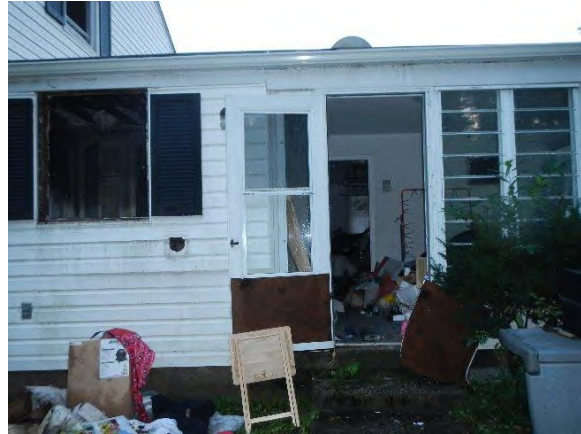
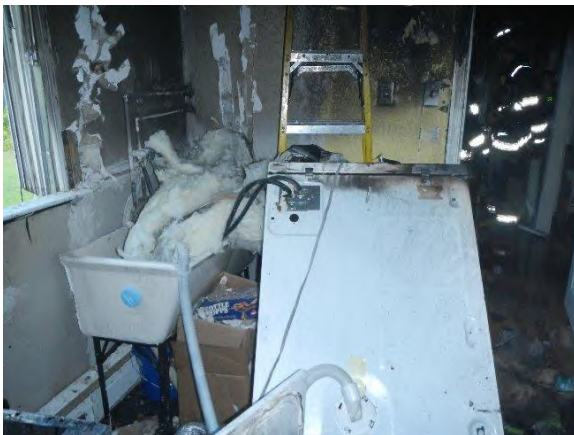
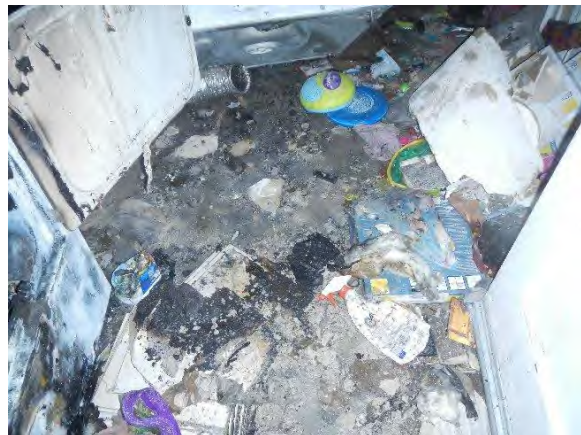
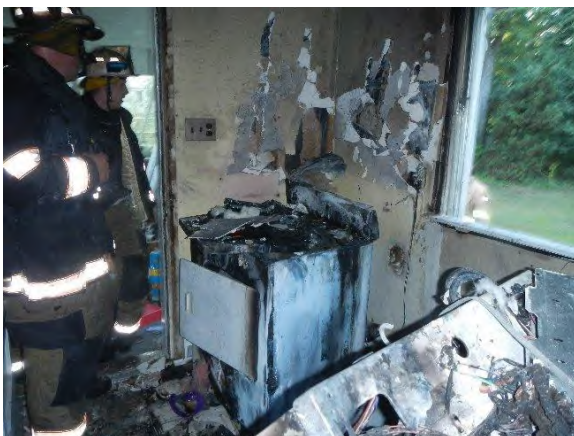
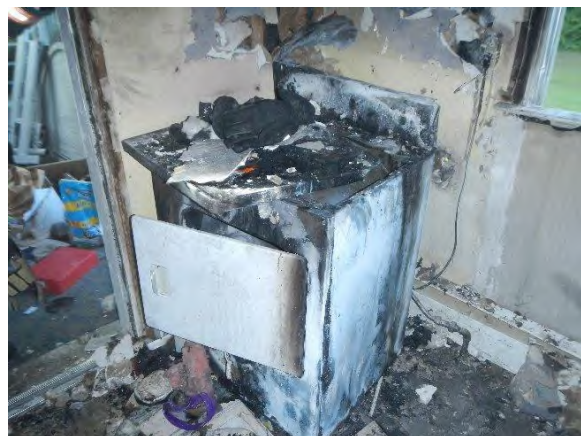
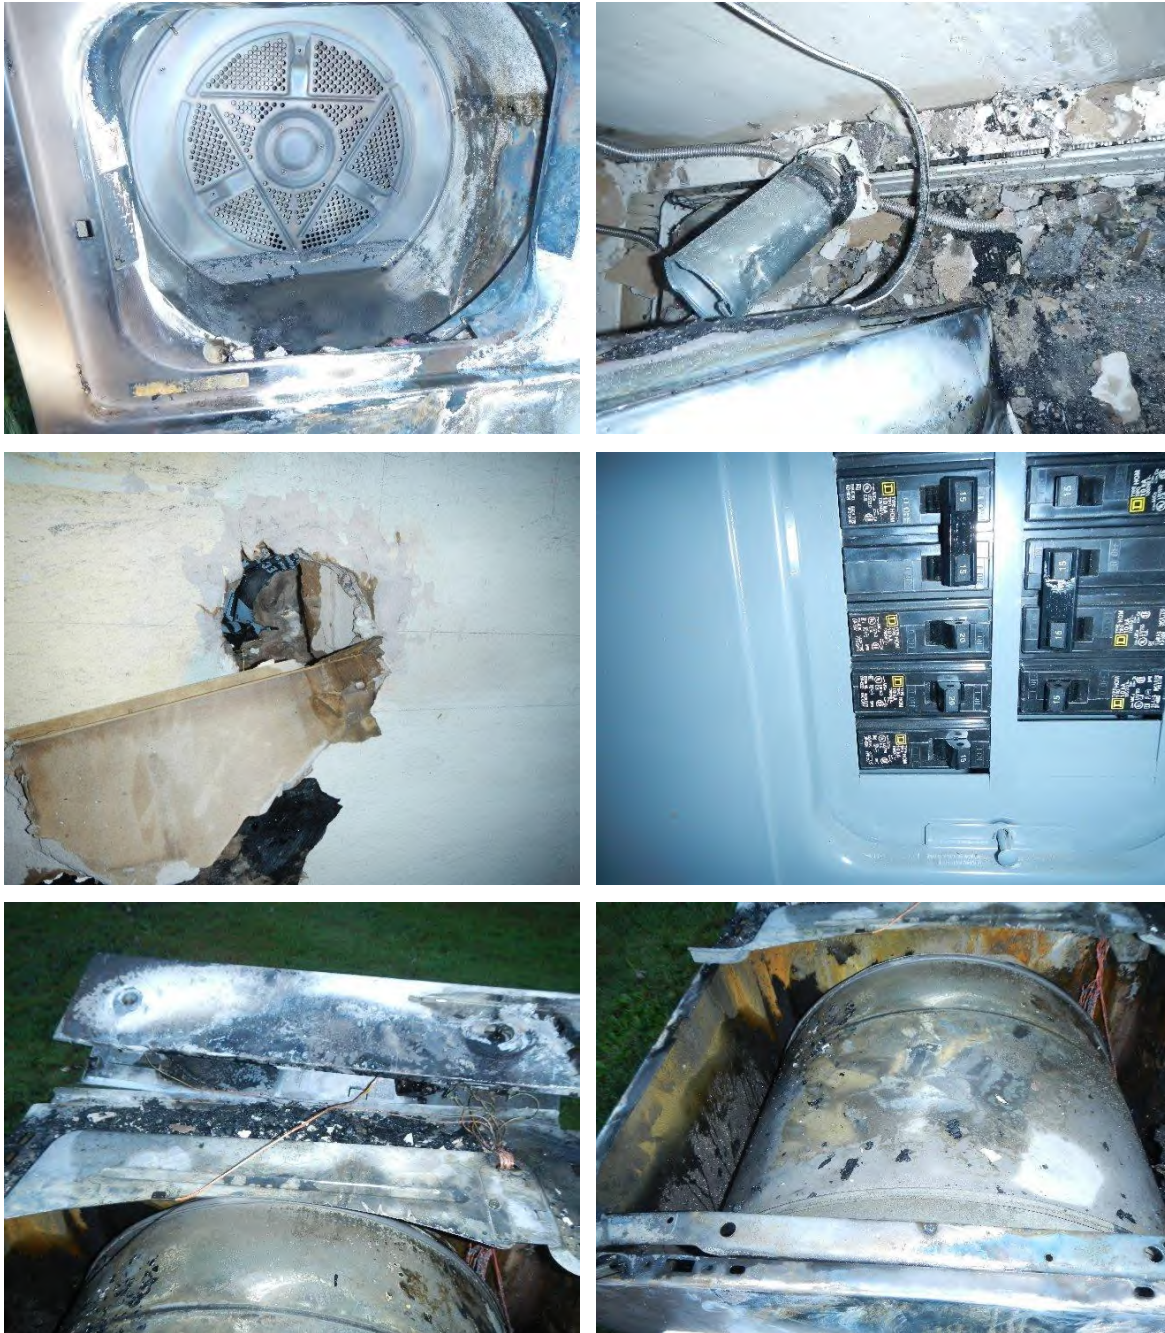
Fire Department Photos

where additional photos of the dryer were taken. The Fire marshal also photographed the electrical panel in the home which showed the 20 Amp, single-pole circuit breaker for the laundry room in the tripped position.

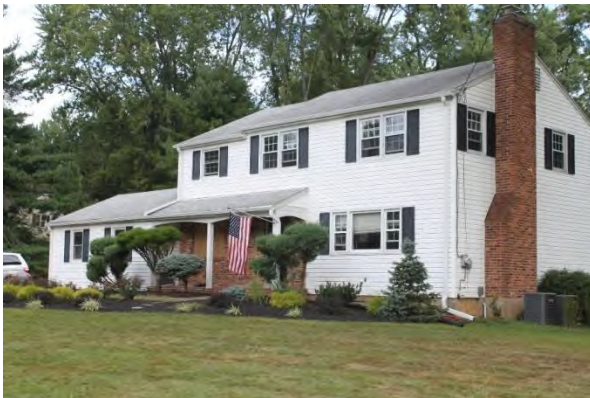
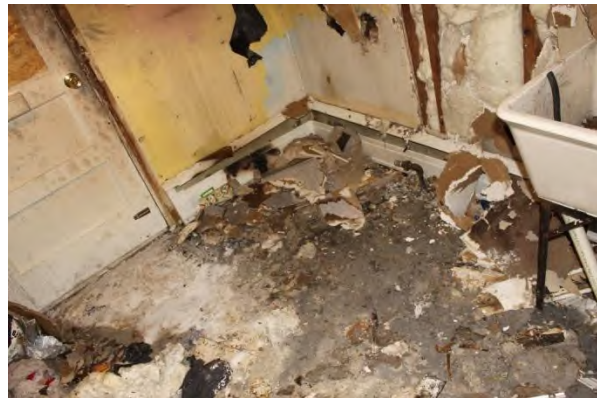
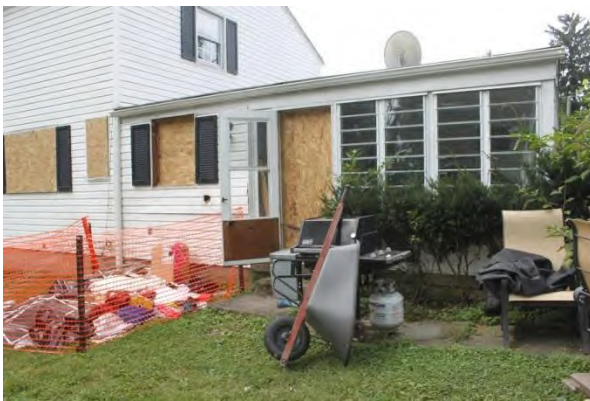
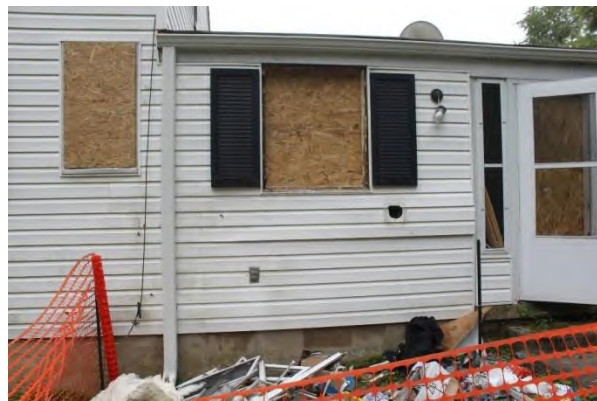
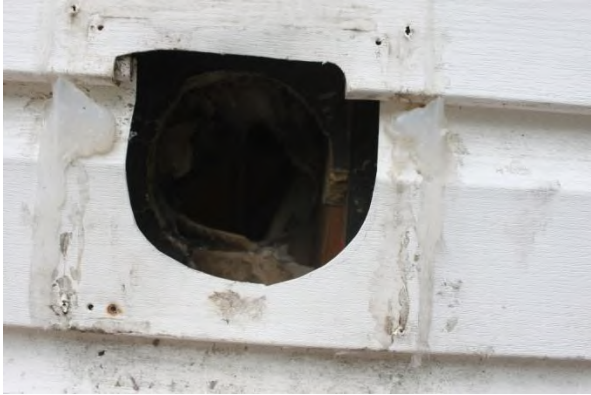
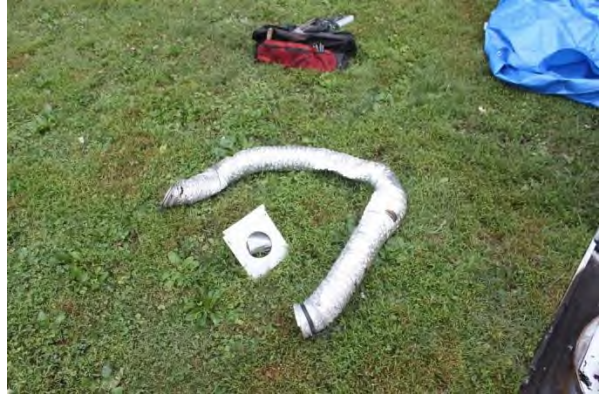
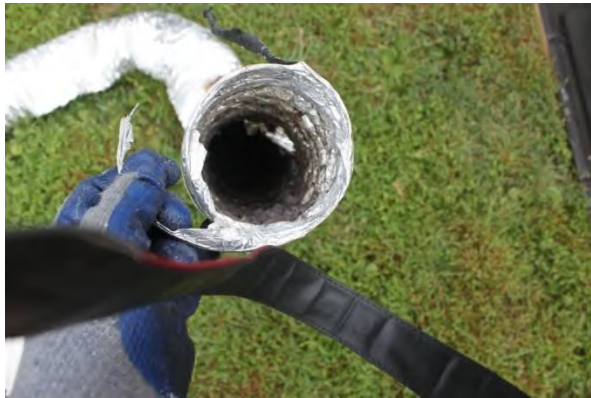
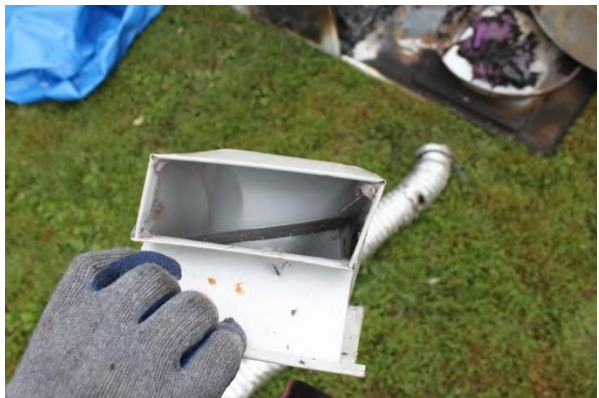
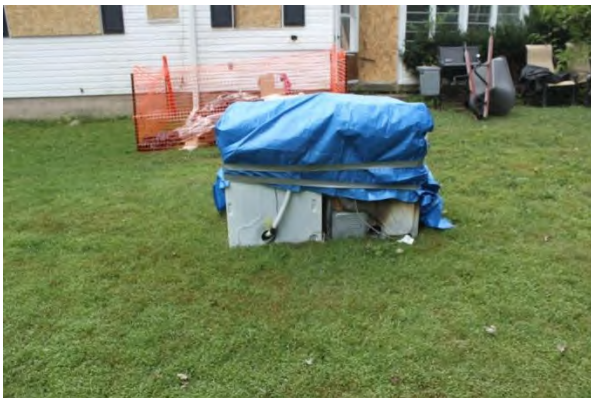
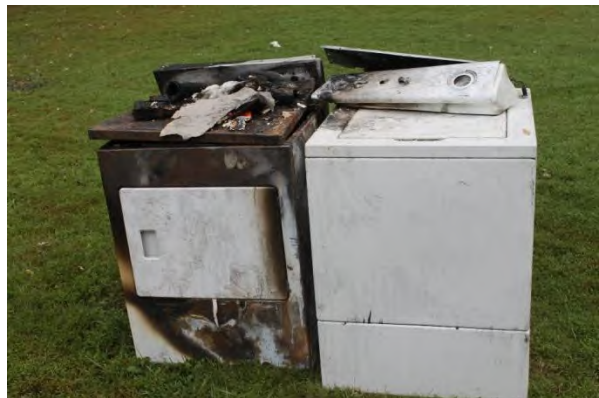
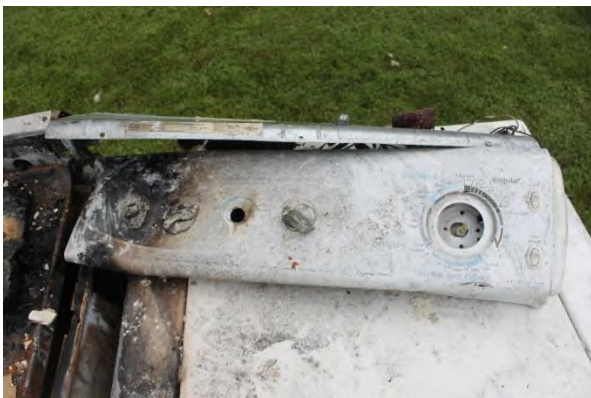
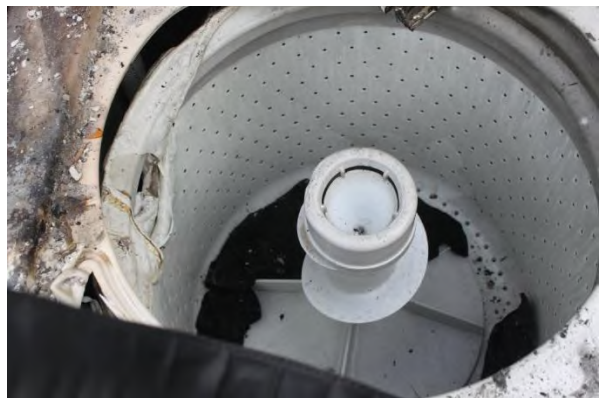
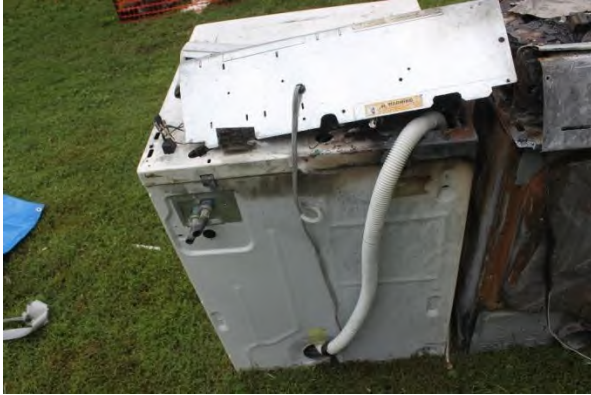
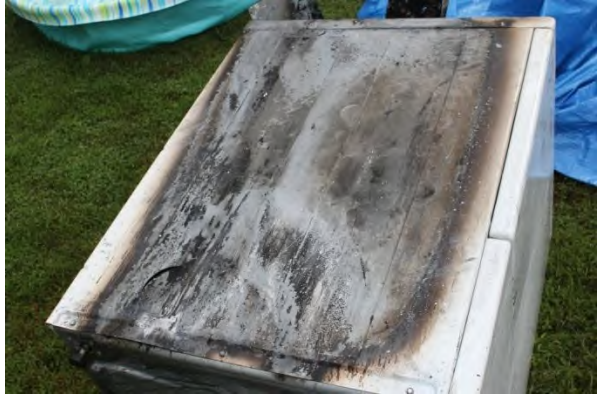
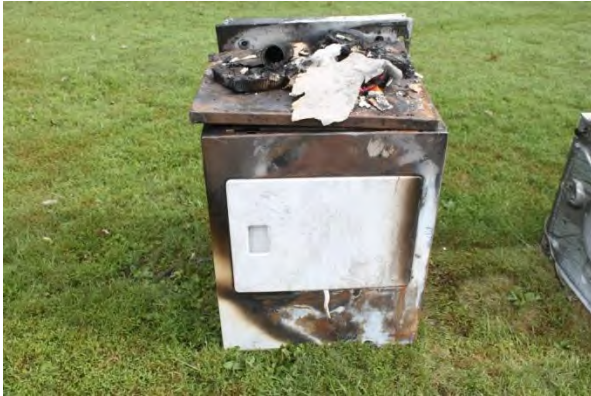
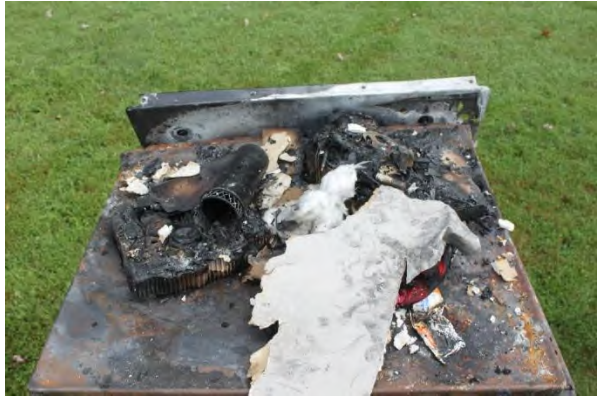
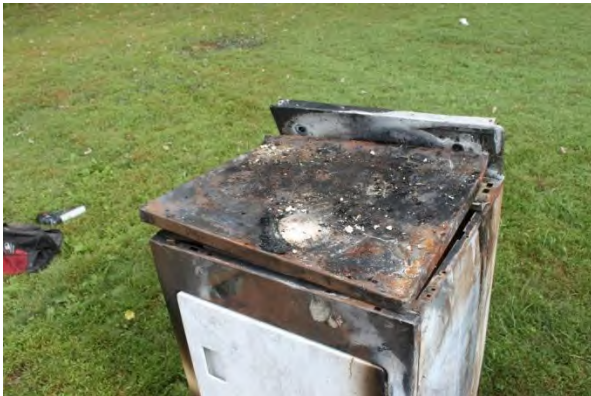
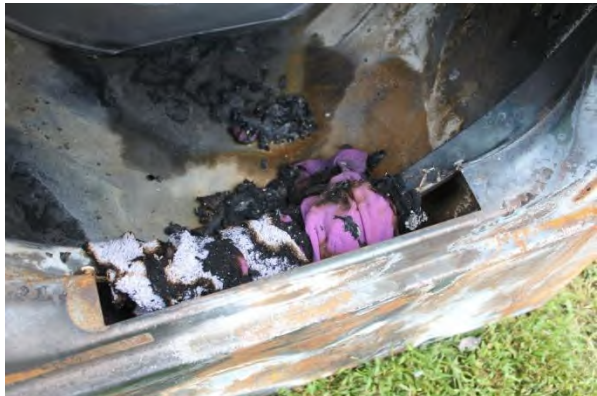
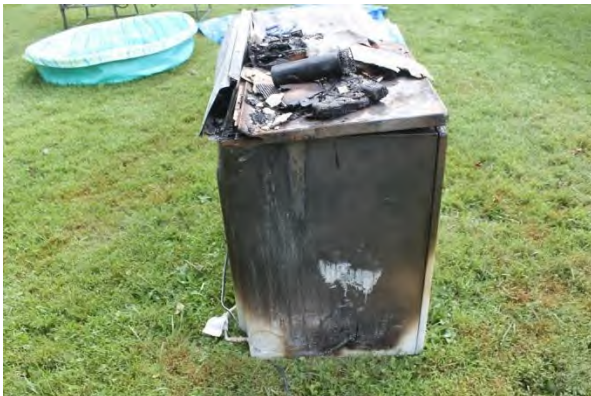
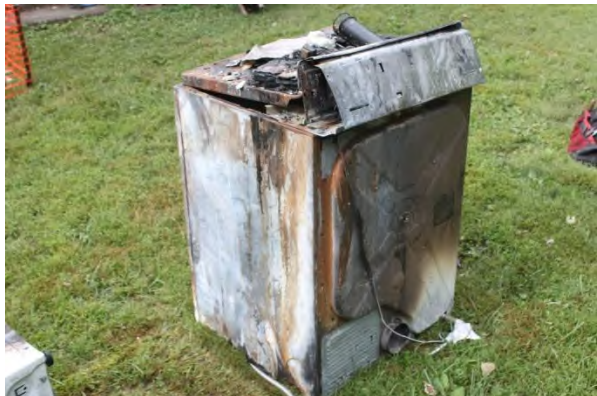
O&C Photos

The washing machine was considerably less damaged than the clothes dryer and, as outlined in Mr. Fry's report, his examination of the washing machine on-scene allowed him to rule out that appliance as a potential fire cause. The clothes dryer was heavily damaged by fire and the clothing load had been mostly consumed or removed by firefighters. The dryer venting had also been removed by firefighters prior to Mr. Fry's first examination of the scene, with the flexible foil clothes dryer transition duct and the metal exterior hood found in the yard. The fire department had pried the metal hood from the short section of rigid piping that is normally attached to the vent assembly that passes through the wall. That item was not found by Mr. Fry. The hood had almost no lint accumulated in it and the flexible foil transition duct displayed only a light lint accumulation on the inner wall of the round duct.

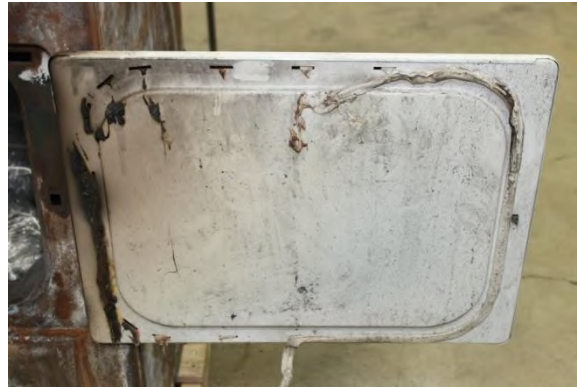
**Interior of Door**

The paint on the interior of the door was mostly intact whereas the paint on the drum opening had been consumed and the front panel heavily oxidized. This indicated the door was open during the fire. The door gasket had been only partly consumed. The door switch had been consumed during the fire. The door catches at either side of the drum opening were consumed. The plastic lint trap at the lower portion of the drum opening had been consumed. The manufacturer's labeling around the drum opening was consumed and both the model and serial number were not legible. Although it was not present during the joint evidence exam, the

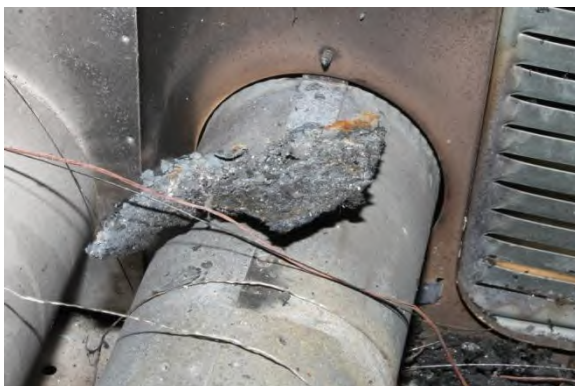
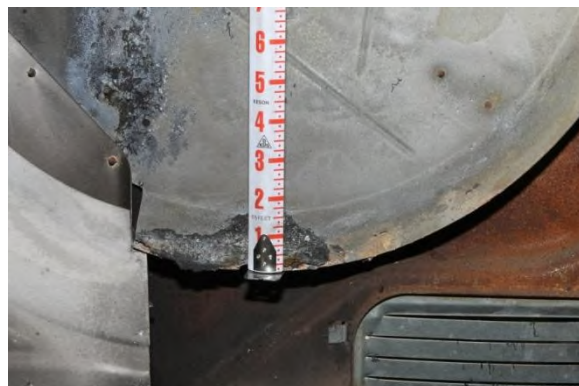
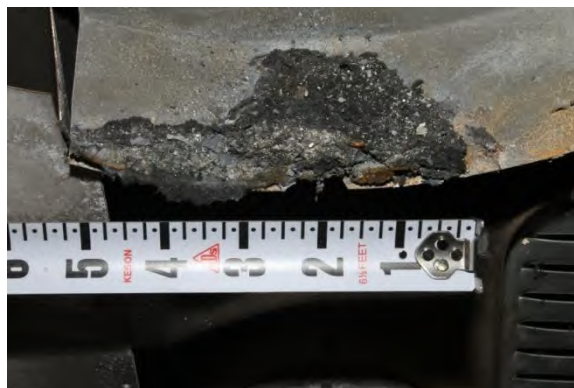
**Mass of Lint Dislodged from Lower Portion of Heater Pan**

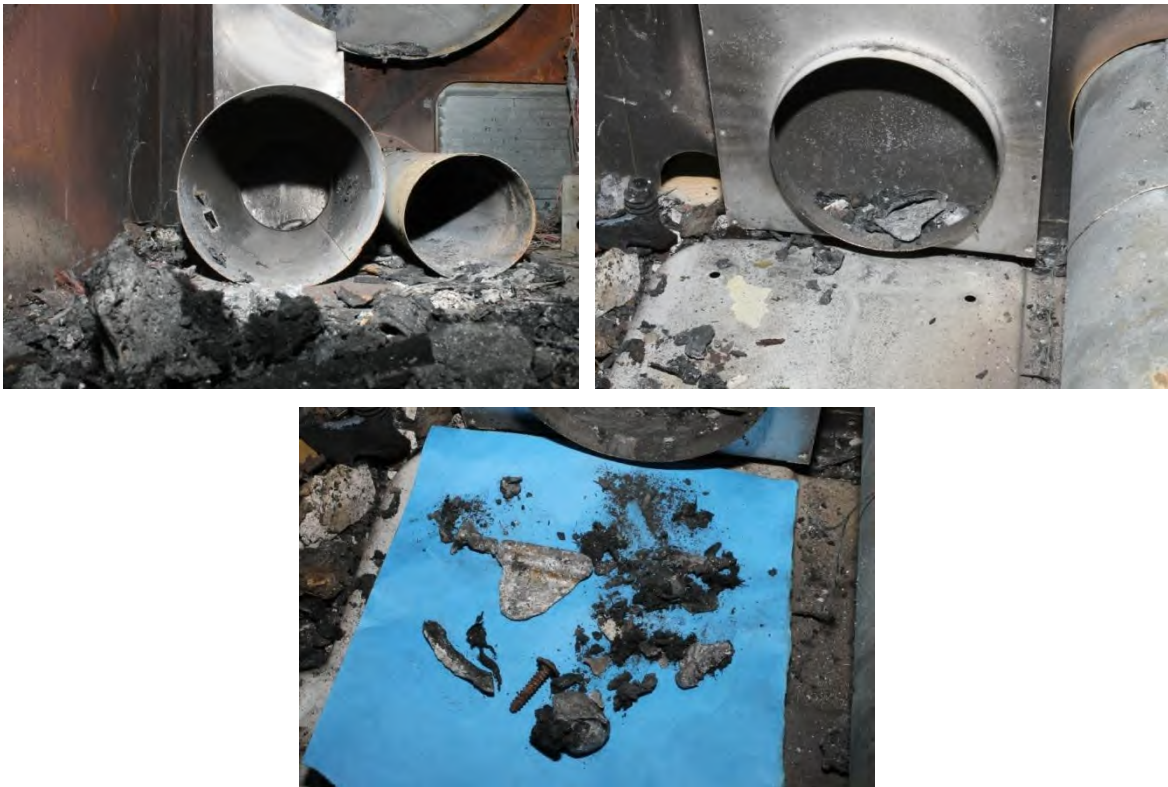
**Intersection of Combustion Chamber and Vertical Heat Duct and Post-Fire Debris**

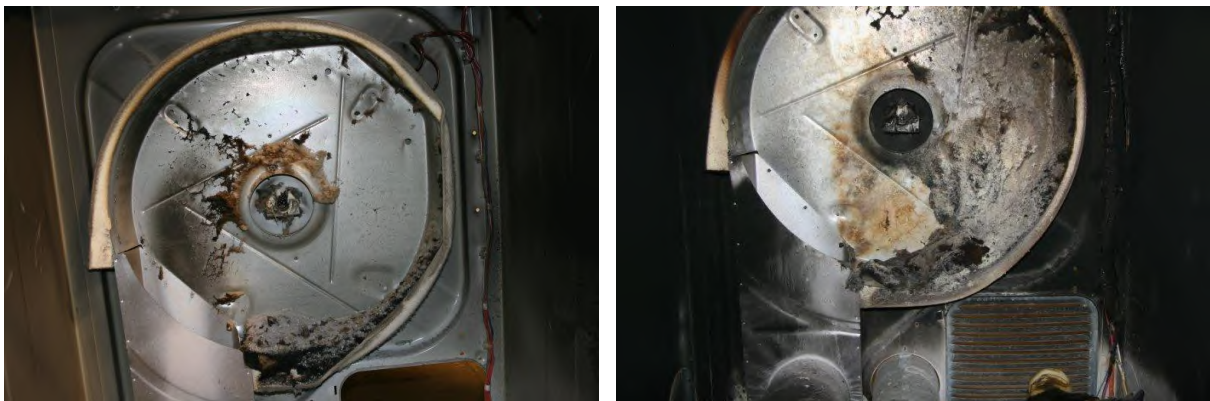
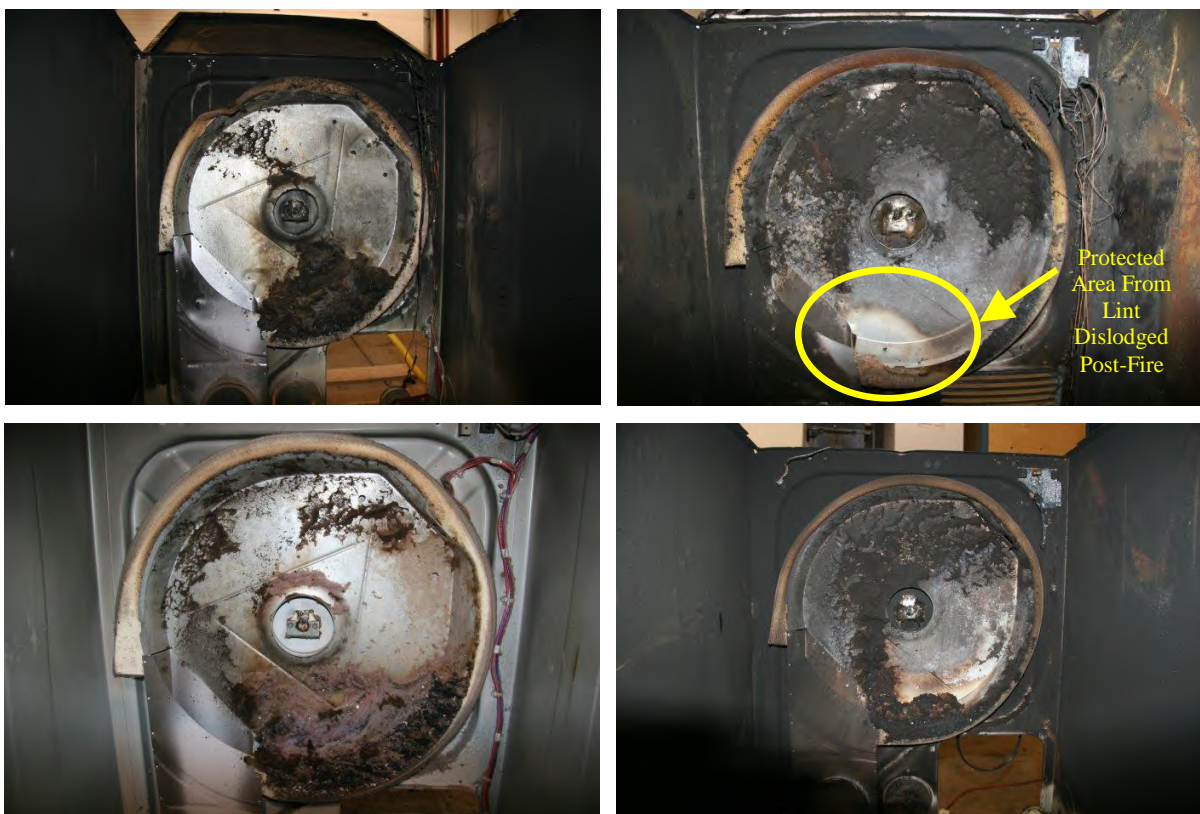
**Photos of Lint Accumulations in Exemplar Burned Gas Dryers**

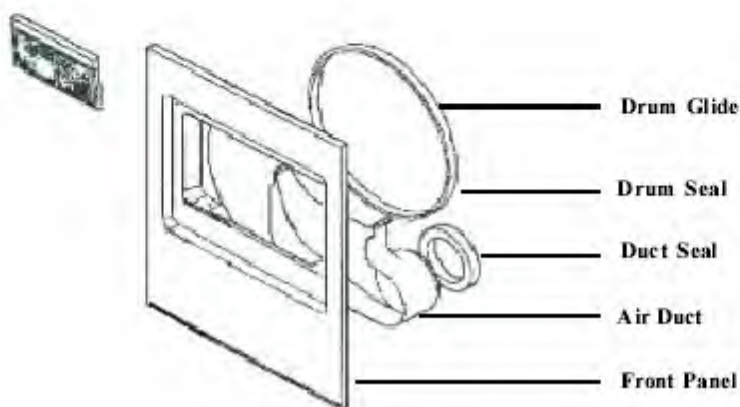
**Electrolux Service Bulletin – November 2000, Page 16**

The statement highlighted above expresses that Electrolux is aware that "short cycling" means that the dryer is operating off of its high temperature limiting safety device as opposed to its operational thermostat. This "short cycling" is manifested by extended drying times. The service bulletin goes on to describe four potential defects of the dryer components that should be assessed by the technician when diagnosing the cause of the extended drying times, including leaks at the door seal, drum glide or seal, seal between the trap duct and blower housing or a defective blower assembly. These defects are directly related to internal components and are independent of installation or maintenance issues that Electrolux typically blames as the only potential causes for reduced airflow within the dryer. And in the statement below, Electrolux warns servicers that vent restrictions are not the sole cause for large amounts of lint observed in the cabinet.

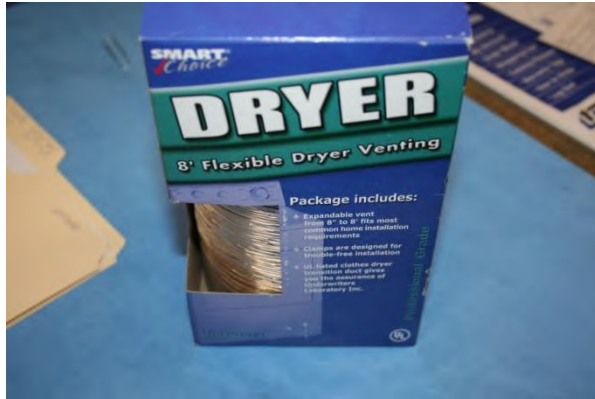
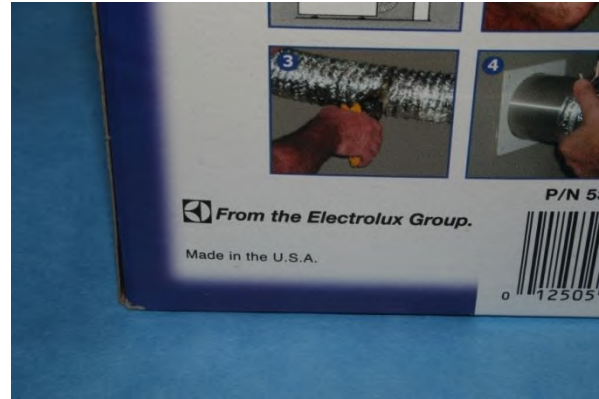
More notably, Electrolux itself has marketed and distribute these same flexible foil transition ducts that they prohibit the use of, under the Electrolux name. An exemplar of this duct was purchased at the same store where their dryers are sold. The packaging of the Electrolux brand flexible foil duct states that it is “universal” and “fits most brands”. There is no instruction not to use flexible foil vent with any of the dryer brands manufactured by Electrolux, such as the subject dryer. The Electrolux packaging further states “UL listed clothes dryer transition duct gives you the assurance of Underwriters Laboratories, Inc.”

**Flexible Foil Transition Ducts Distributed by Electrolux**
